ENVIRONMENTAL MEMORANDUM

Red Chris Development Company Ltd.
200–580 Hornby Street, Vancouver, BC V6C 3B6

Date: August 11, 2015

Re: Red Chris Monitoring Committee Environmental Report Jul 28 – Aug 11, 2015

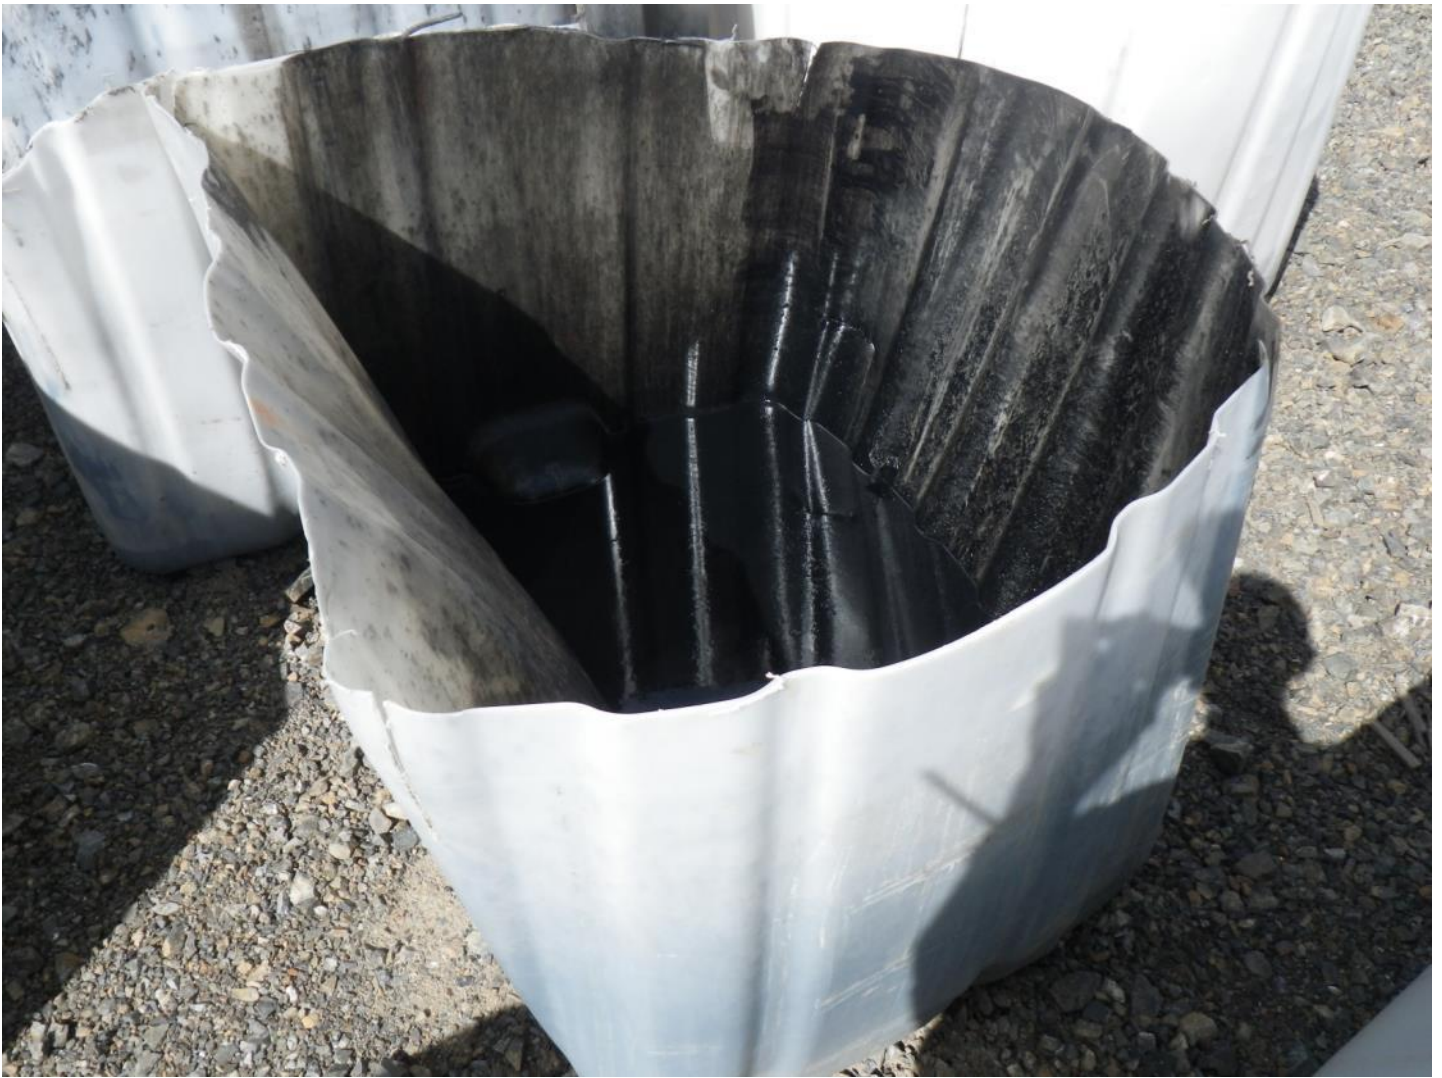
Aug 9 Lots of waste oil cubes at the erection pad had been cut open over the years and left to collect water. This has made cleanup difficult.
